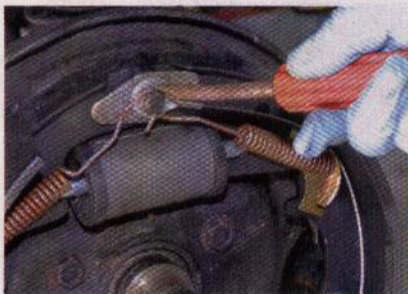
10 The primary brake shoe was next, along with the Heavier Trick Spring and retainer. Parry then installed the star, or adjuster wheel, and brake-lever spring. This is all-new hardware provided in the kit. He finished this side by hooking the lever spring to the adjuster lever.

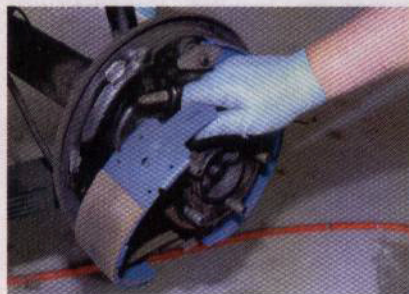
13 The procedure for the rear brakes is similar to that done on the front. Rear drum disassembly began with the removal of the OE secondary return spring, followed by the primary retainer and spring, then the primary brake shoe. Once the primary shoe was off, the secondary shoe and strut rod came off. Parry then moved around to the back side of the backing plate to remove the rear hard line.

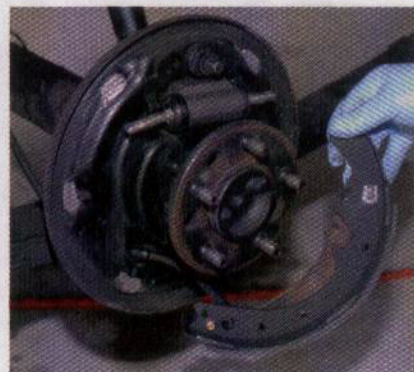
15 As with the front brake assembly, Parry mounted the high-volume wheel cylinder using the new bolts provided in the kit; installed the cylinder plungers (using plenty of antiseize); mounted the adjuster cable tab onto the secondary rear shoe; and then mounted the shoe itself. The anchor plate was installed, followed by the Heavier Trick Spring for the secondary shoe. The star wheel was assembled, then Parry hooked the overload spring to the primary shoe. Once the primary shoe was in place, its Heavier Trick Spring was installed.

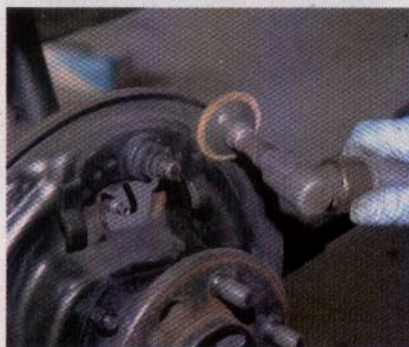
14 Prepping the rear backing plate was a two-step process. First, Parry sprayed liberal amounts of brake cleaner on the plate to get rid of accumulated brake dust. Then he buffed the contact areas on the plate using a small grinder, and followed that step with liberal amounts of antiseize.

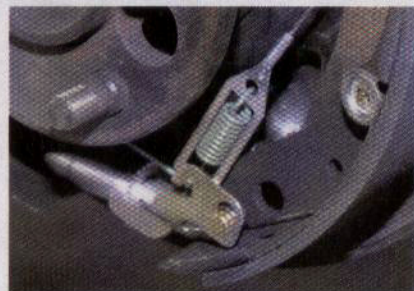
16 Here you can see the completed adjuster wheel, lever spring and adjuster overload spring assemblies in place. The shoe installation was done.

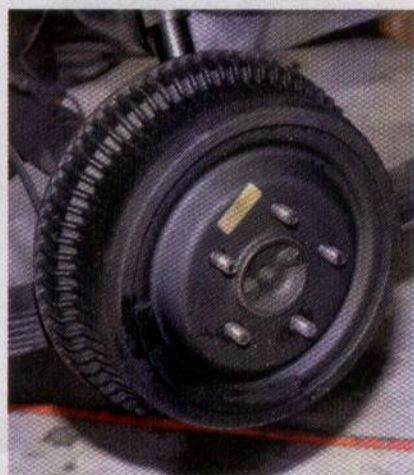
17 The finished driver-side rear brake looked like this after Parry put on the cryogenically treated brake drum.
